GLENN LUKOS ASSOCIATES
EXHIBIT 5

**CANYON HILLS TREE
INVENTORY**
Tree Photographs

Tree Photographs

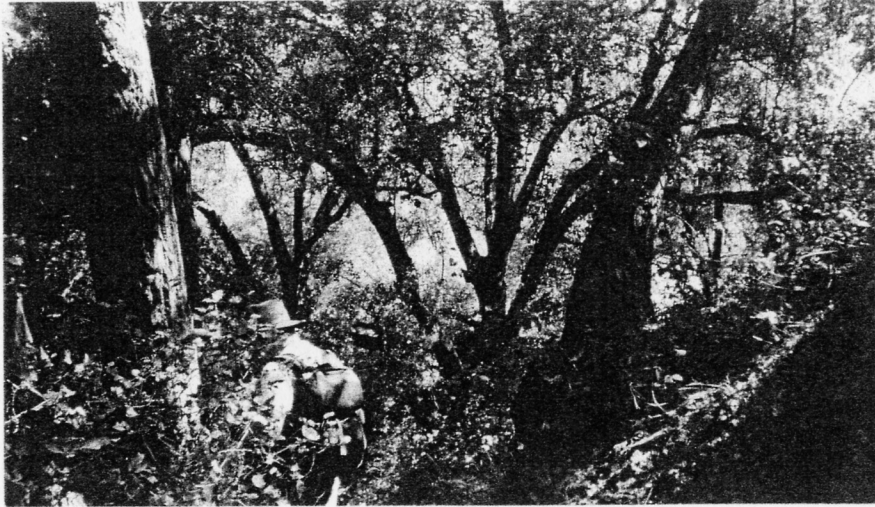
Photograph 1. Oak tree nos. 10-14, from left to right

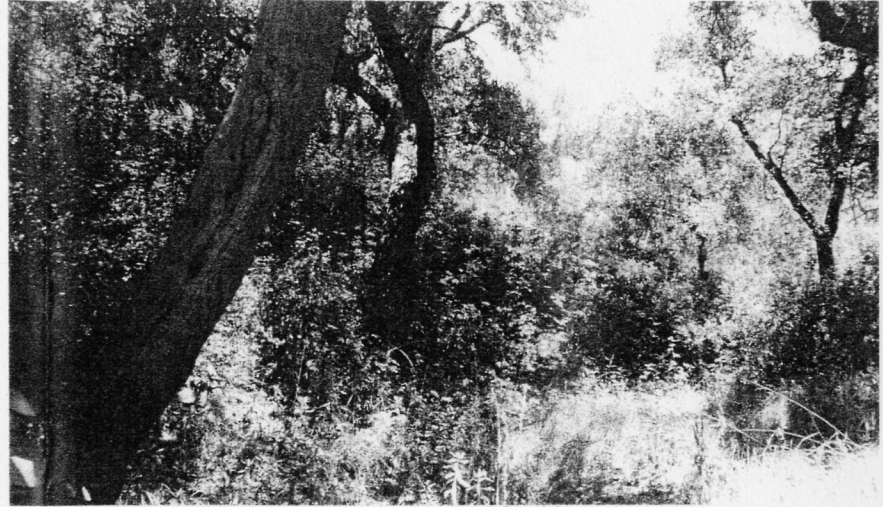
Photograph 2. Oak tree nos. 23, 51, and 50, from left to right.

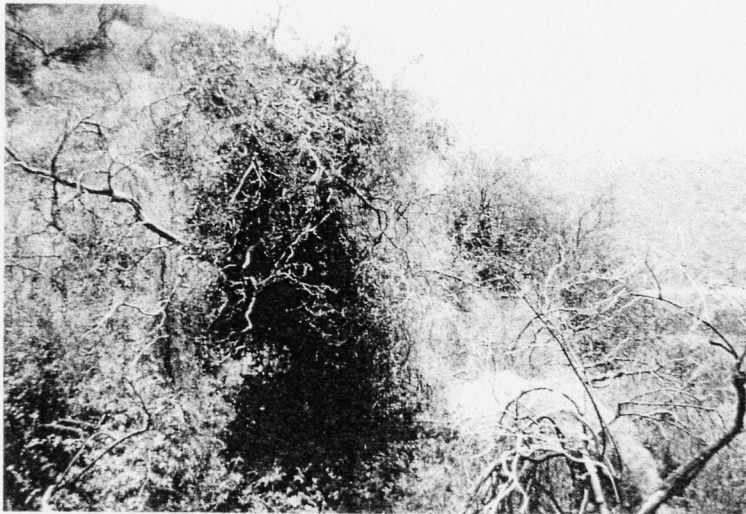
Photograph 3. On Duke property, oak no. 30 with oak no. 29 in background

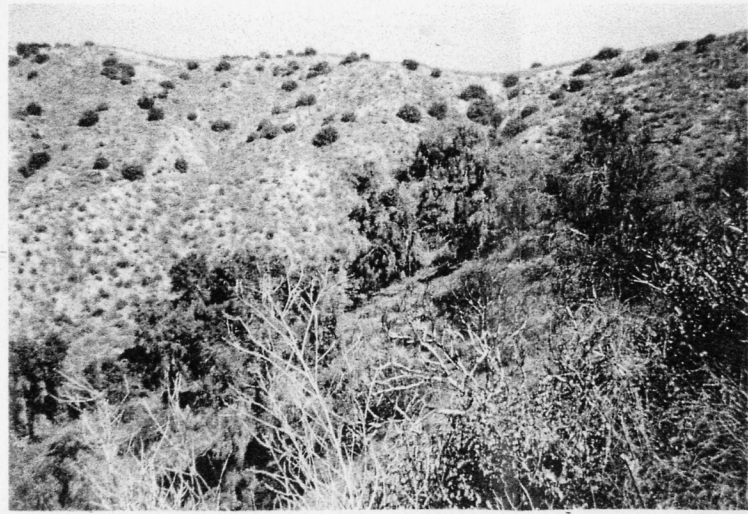
Photograph 4. View looking north into Duke property with tree nos. 33, 36-54, 61, and 62

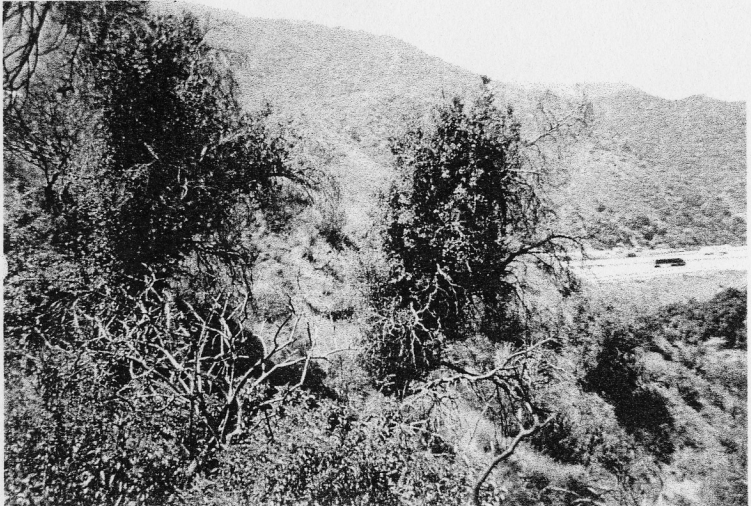
Photograph 5. View looking southwest across Duke property toward tree nos. 55 and 56.

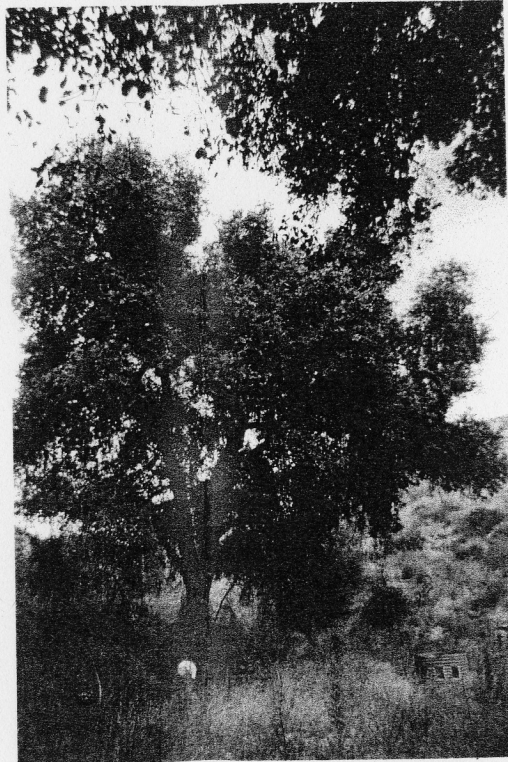
Photograph 6. Exceptional coast live oak, no. 103, with 34-inch DBH at downstream end of small drainage near Interstate 210

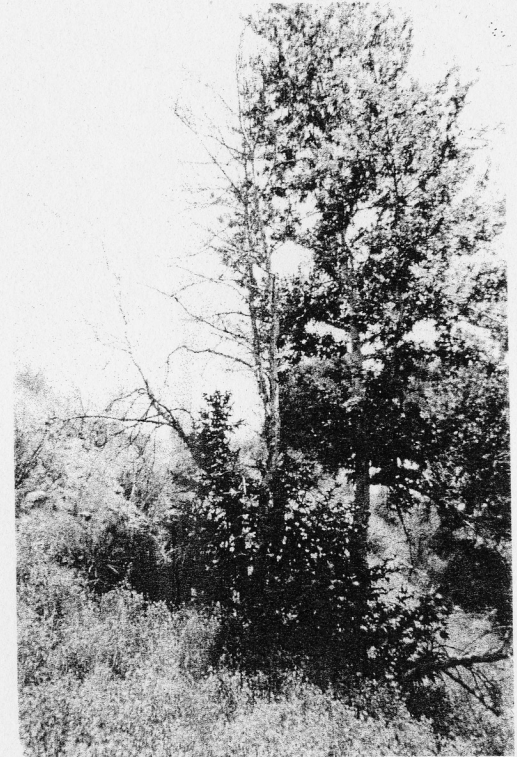
Photograph 7. Western sycamore, tree no. 153, recovering from fire damage.

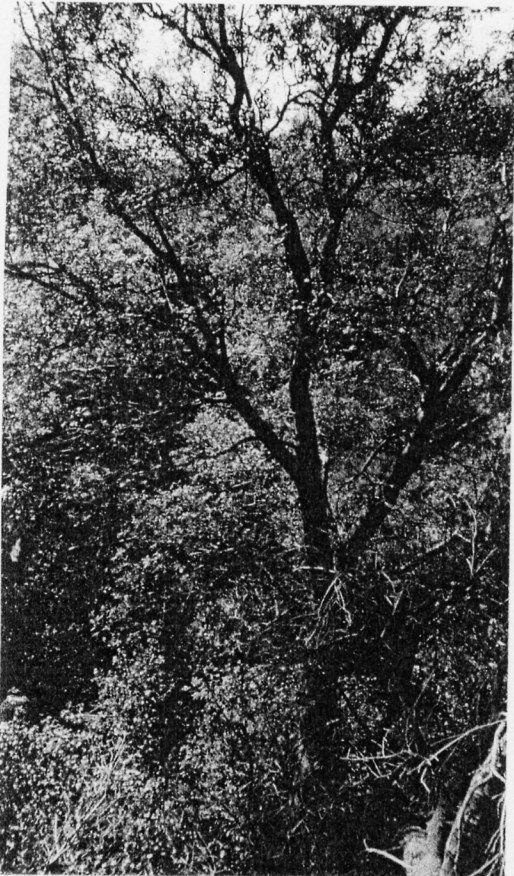
Photograph 8. Ten-inch DBH coast live oak no. 177 within dense vegetation.

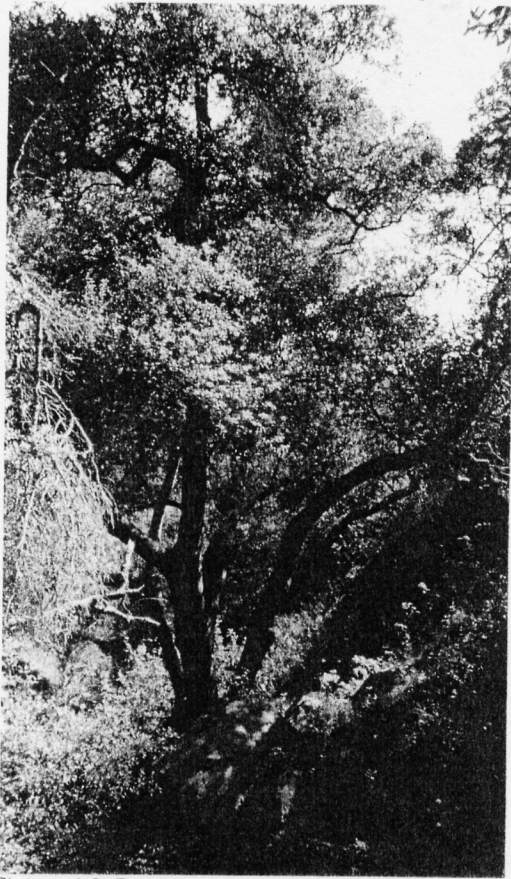
Photograph 9. Exceptional four-trunk coast live oak no. 179 at bottom of canyon.

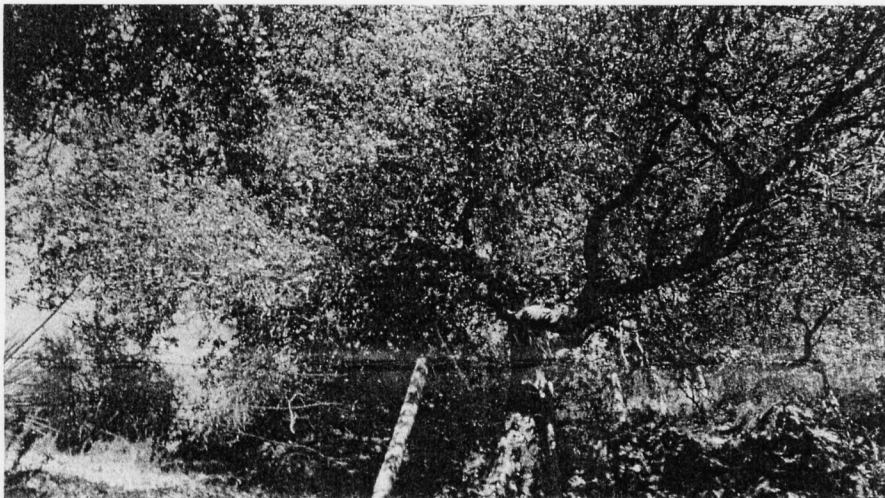
Photograph 10. Coast live oak no. 184 growing along fence line interior to project limits.

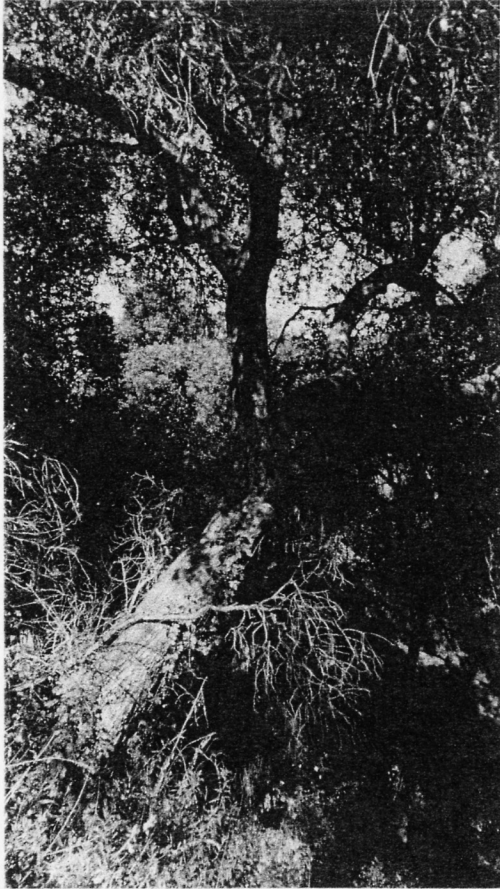
Photograph 11. Coast live oak no. 185 growing within poison oak.

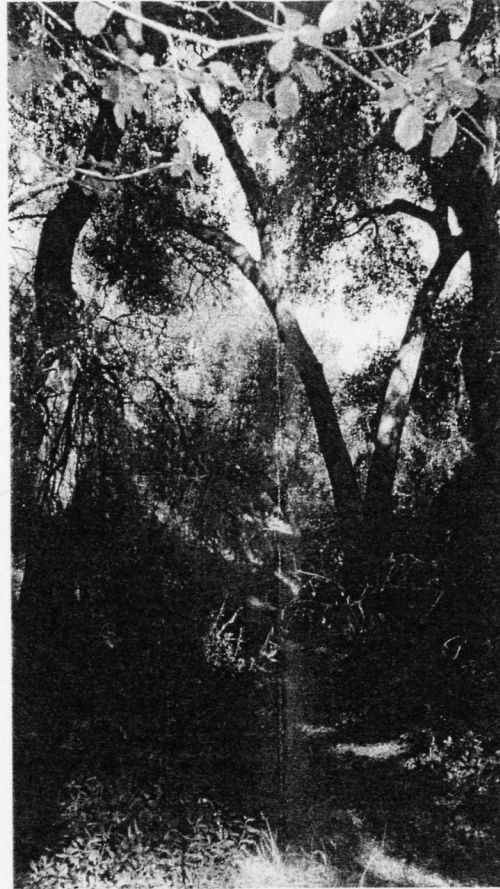
Photograph 12. Coast live oak nos. 186, 187, and 188 at edge of streambed.

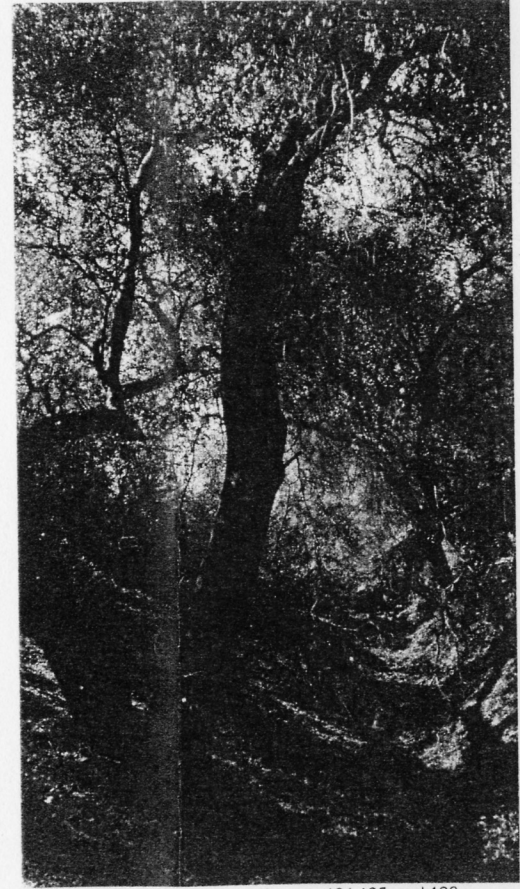
Photograph 13. Coast live oaks nos. 194, 195, and 196, with DBHs of 24, 25, and 21 inches, respectively.

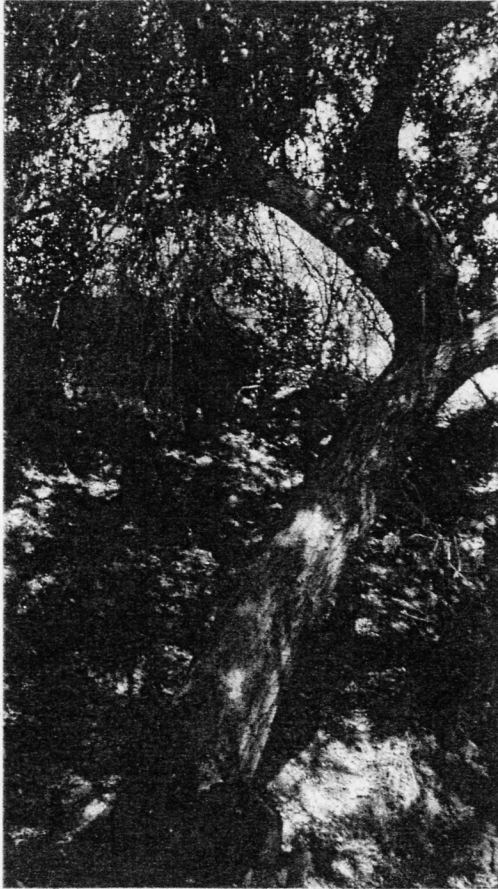
Photograph 14. Coast live oak no. 199; note lean and cavity at bottom of picture from missing trunk.

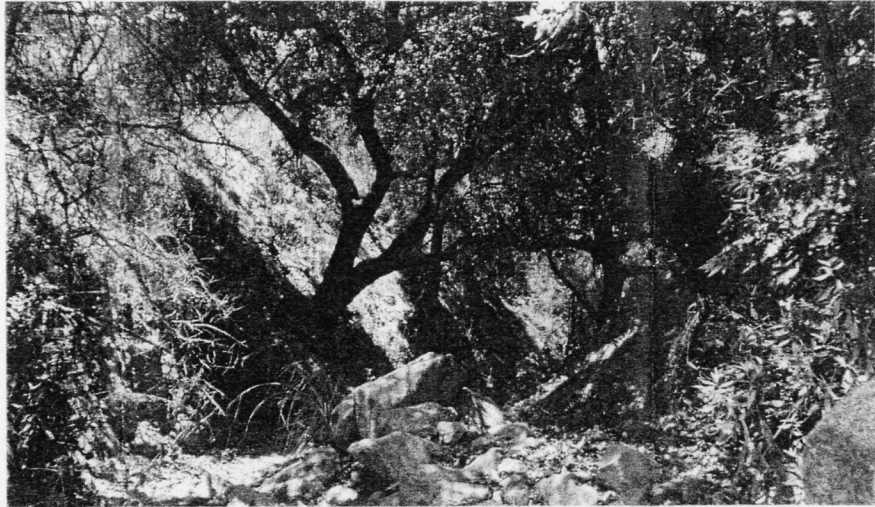
Photograph 15. Coast live oaks nos. 200, 201, and 202, with DBHs of 23, 33, and 17 inches, respectively.

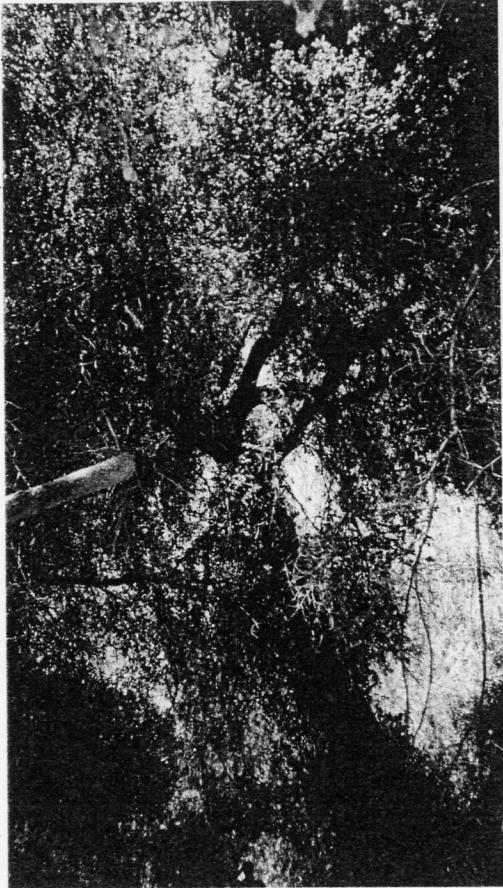
Photograph 16. Coast live oak no. 223 on streambank.

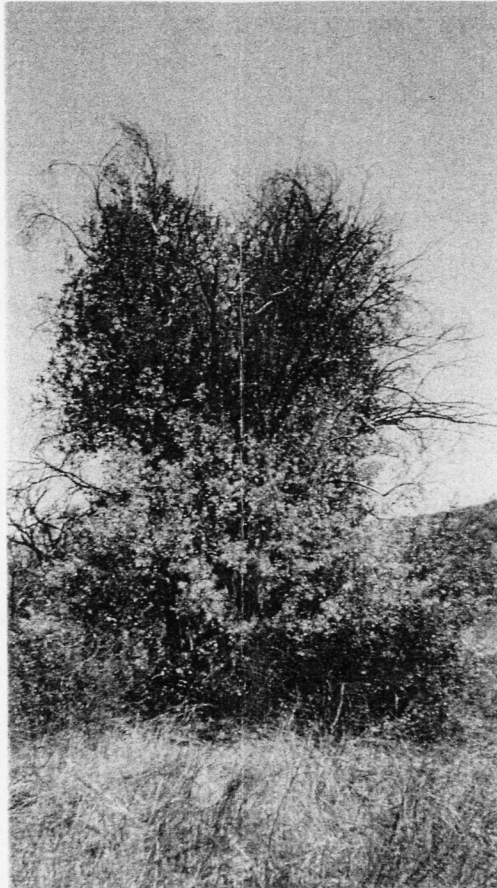
Photograph 17. Fire-damaged, resprouting coast live oak no. 229, with Mexican elderberry at base.

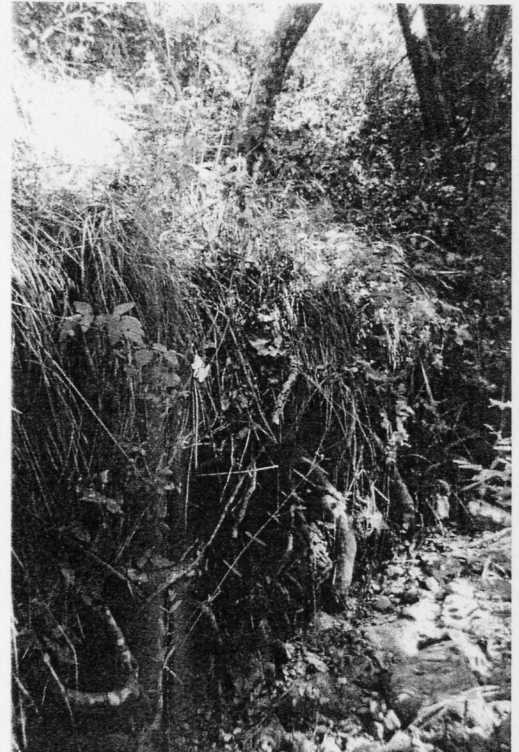
Photograph 18. Note exposed root of Western sycamore no. 238 on streambank.

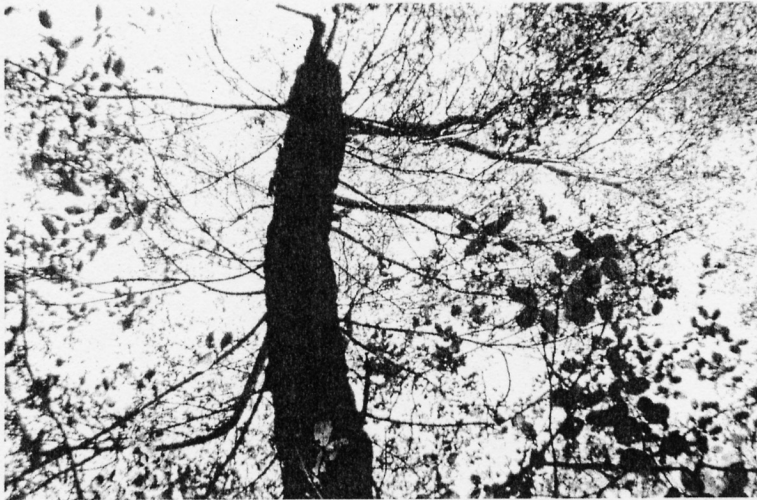
Photograph 19. Coast live oak no. 260 exhibiting significant damage to scaffold branch (photo taken from beneath branch).

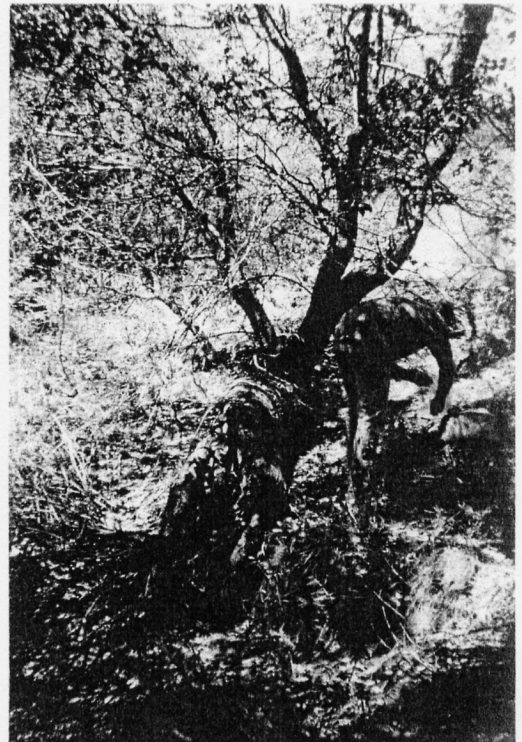
Photograph 20. Note significant heart rot and cavity on coast live oak no. 264

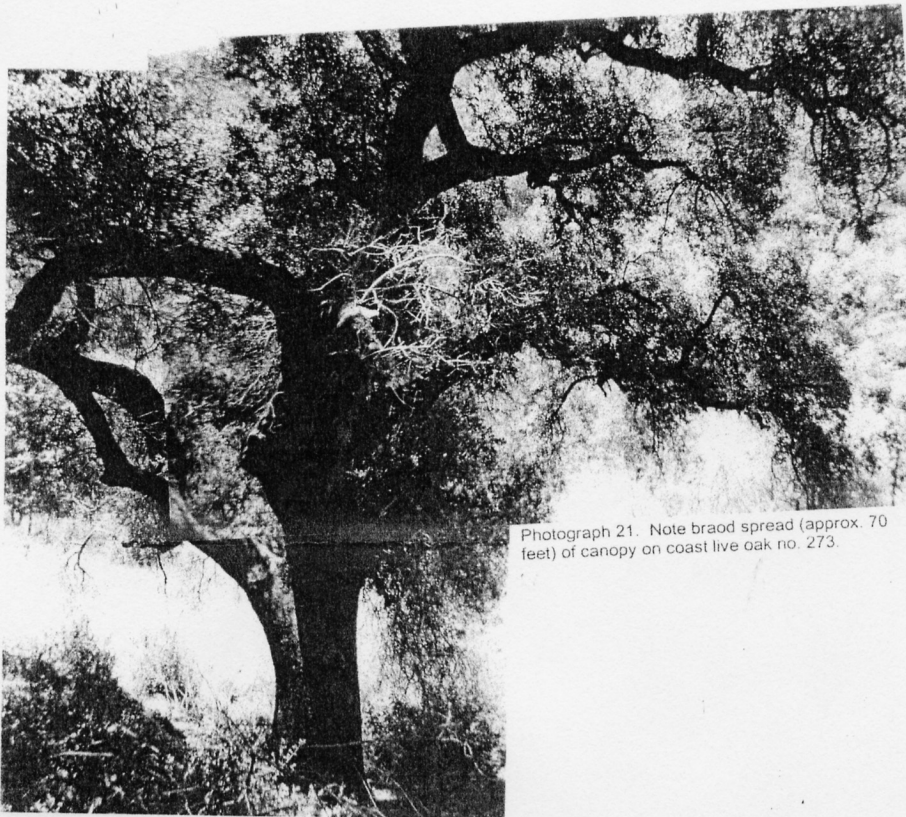
Photograph 21. Note broad spread (approx. 70 feet) of canopy on coast live oak no. 273.

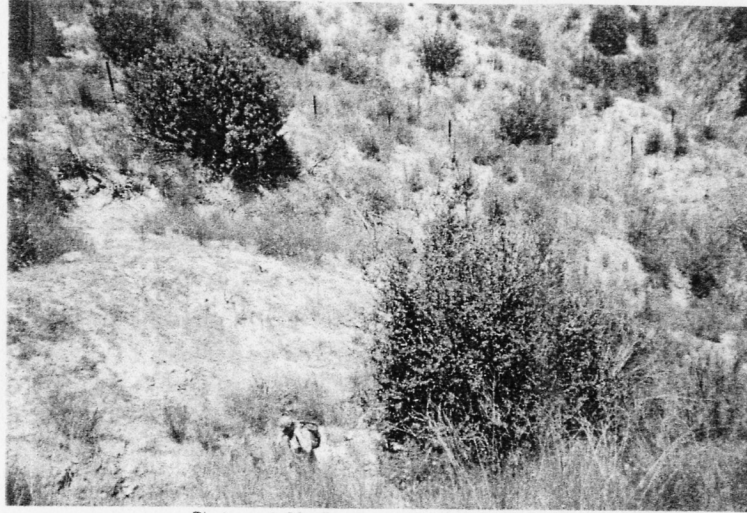
Photograph 22. Small coast live oak no. 285.

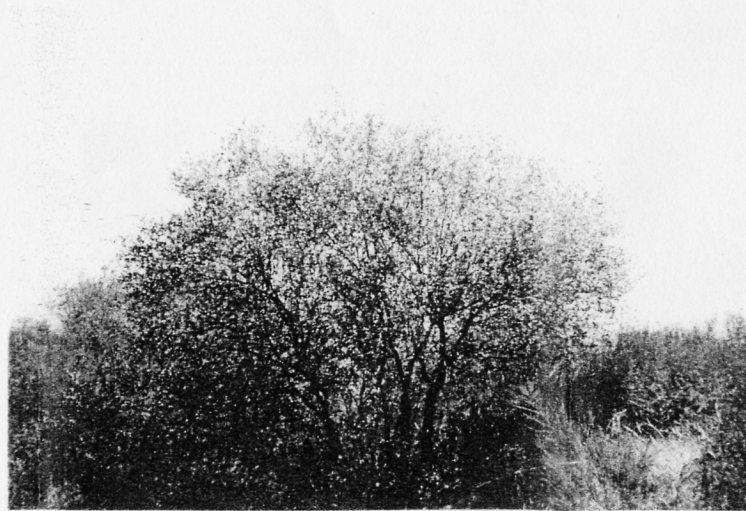
Photograph 23. Coast live oak no. 292.

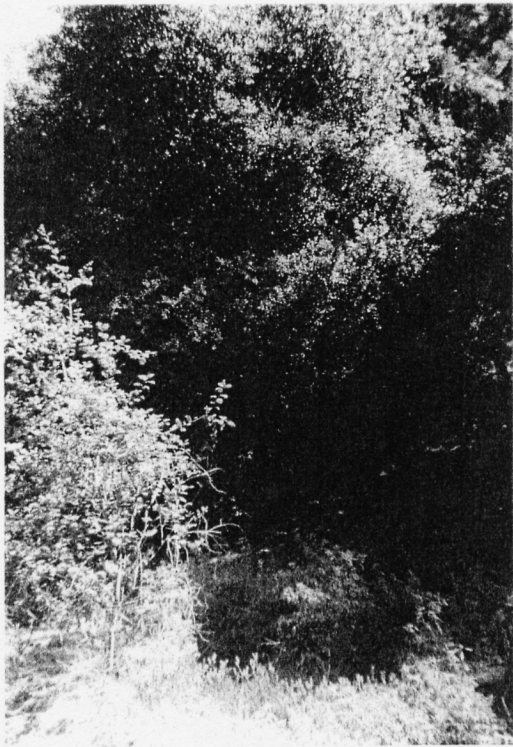
Photograph 24. Coast live oak no. 359.

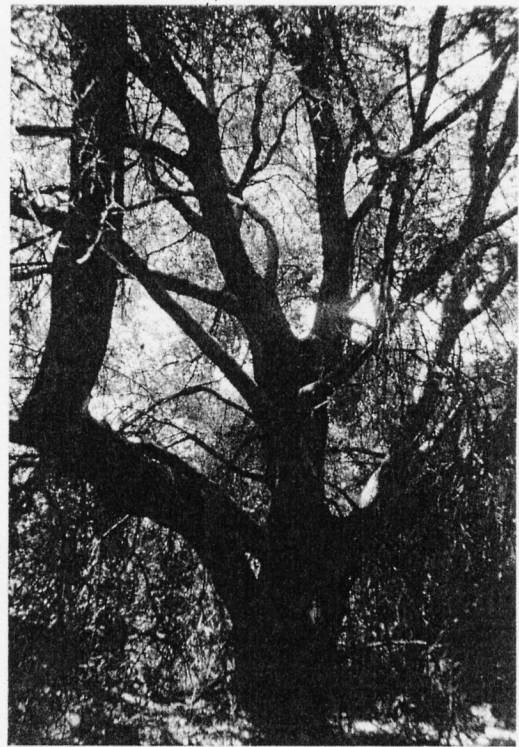
Photograph 25. Large coast live oak no. 362, DBH 33 inches.

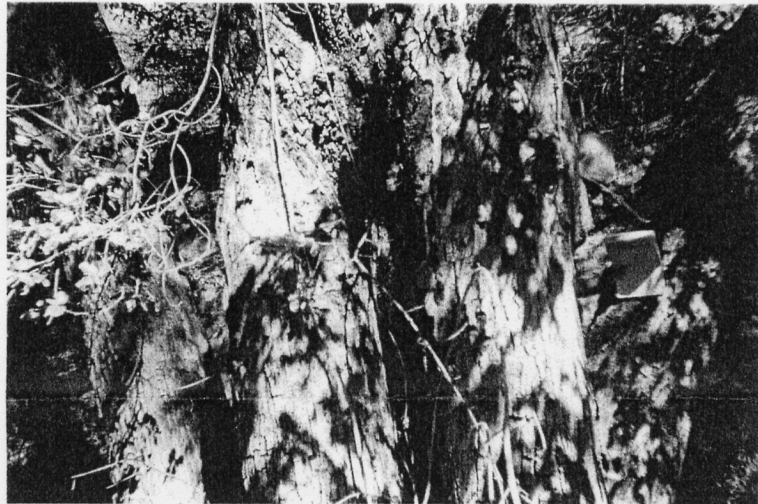
Photograph 26. Coast live oak no. 372 exhibits narrow angle of attachment of codeominant leaders which merge into each other at approximately six feet above ground, forming natural graft.

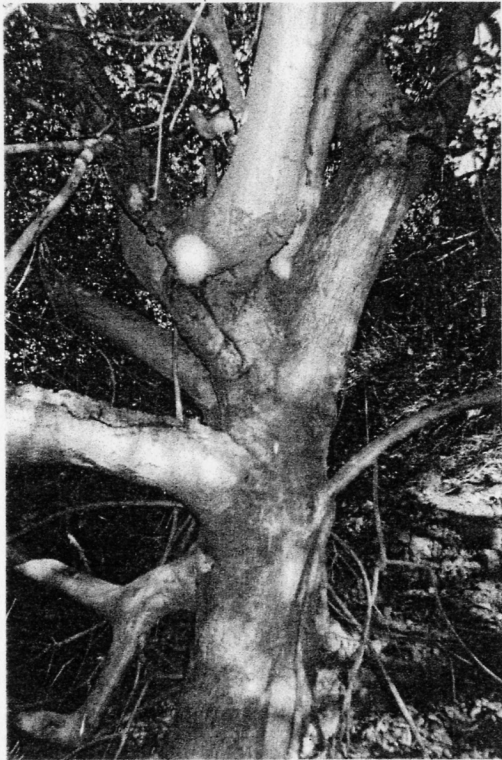
Photograph 27. Fire damaged coast live oak no. 396 exhibit multiple narrow angles of attachment, embedded bark, and exposed heart rot.

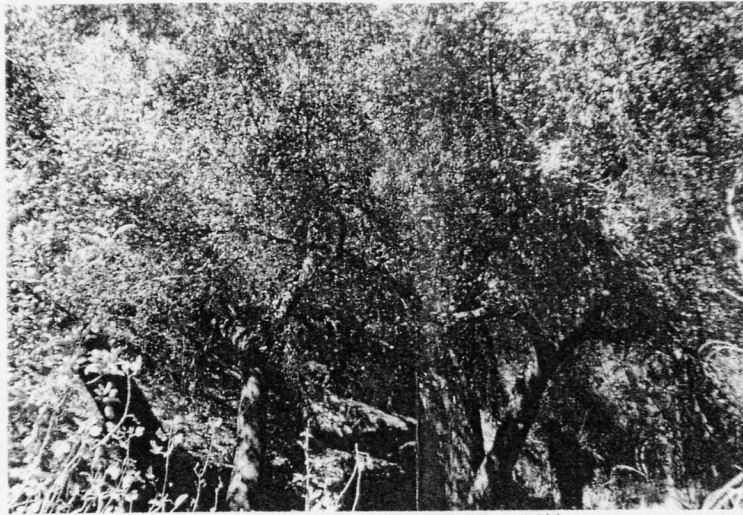
Photograph 28. Coast live oak nos. 412, 413, and 414.

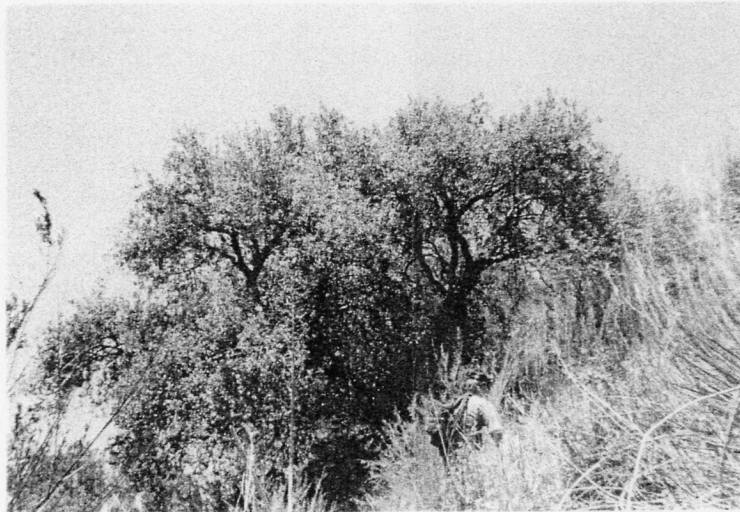
Photograph 30. Fire-damaged coast live oak no. 418 isolated on slope

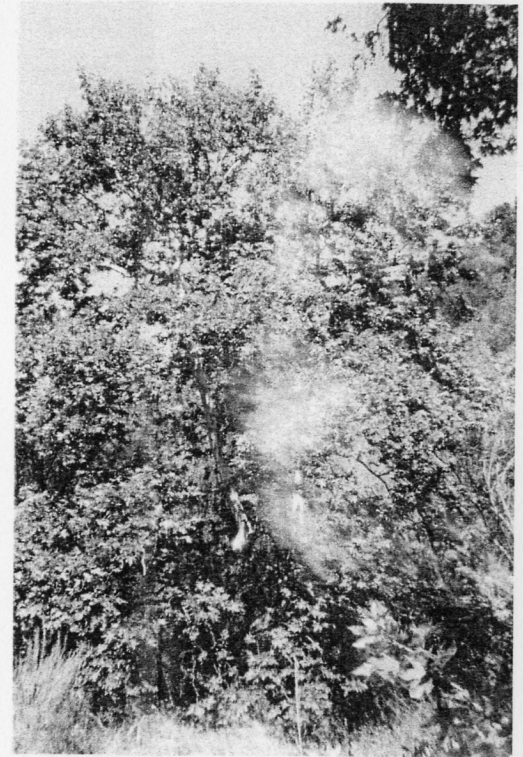
Photograph 29. Exceptional western sycamore no. 415 is approximately 70 feet tall.

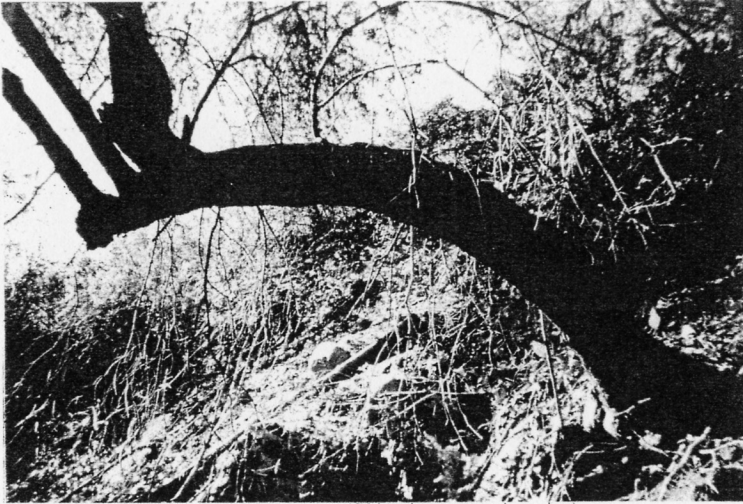
Photograph 31. Coast live oak no. 476 leaning across streambed.

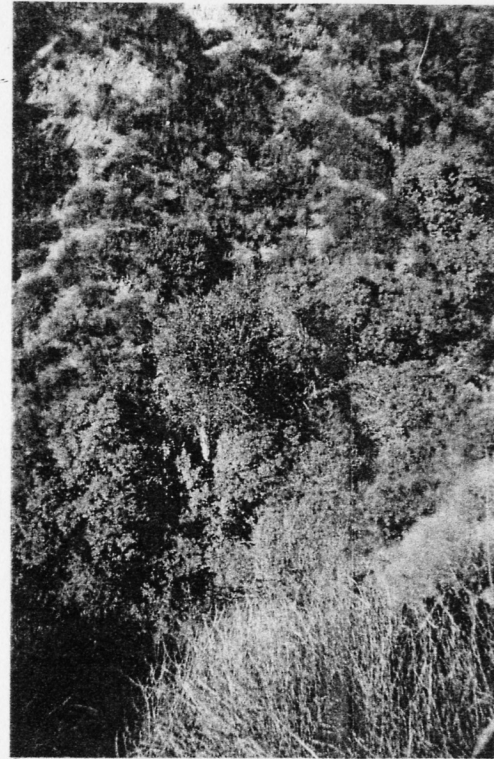
Photograph 32. Coast live oak no. 478 located in steep ravine at western edge of development site south of Interstate 210.

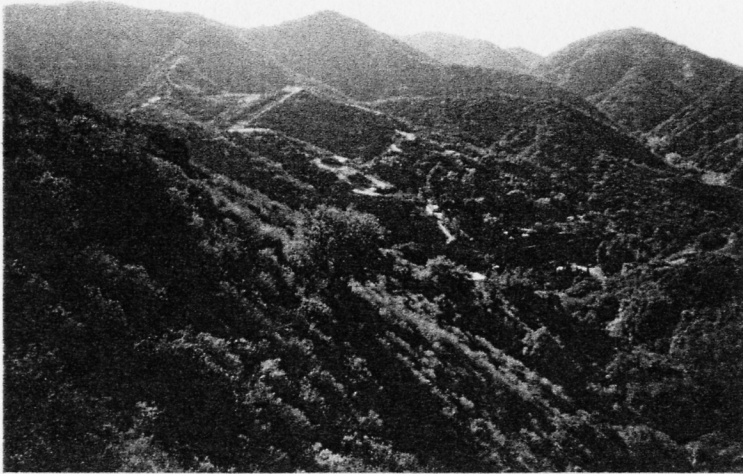
Photograph 33. Coast live oak no. 479 located in steep slope at western edge of development site south of Interstate 210. La Tuna Canyon Road residences visible in background.

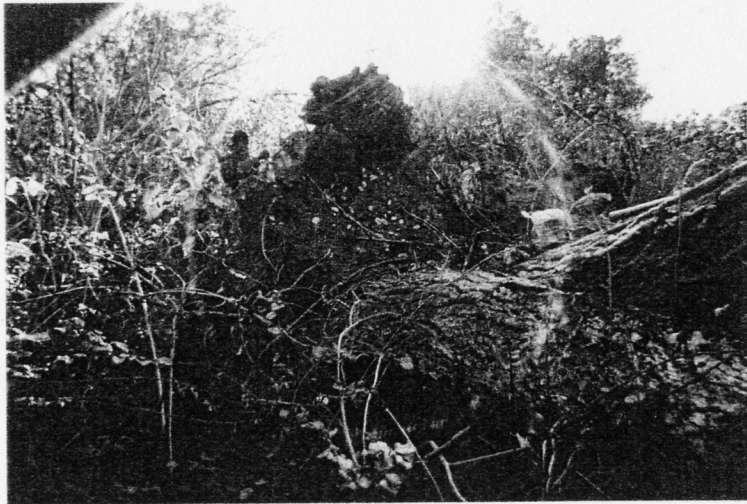
Photograph 34. Fallen coast live oak with exposed roots; tree no. 485.

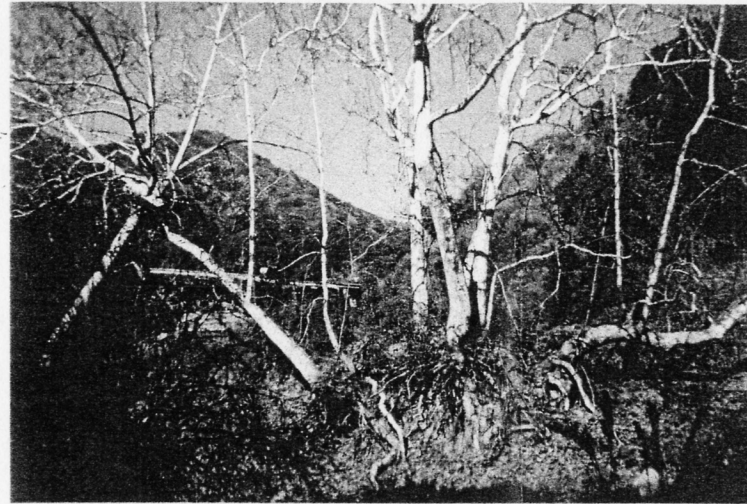
Photograph 35. View of western sycamores showing eroded soil along stream bank; tree nos. 489 & 490.

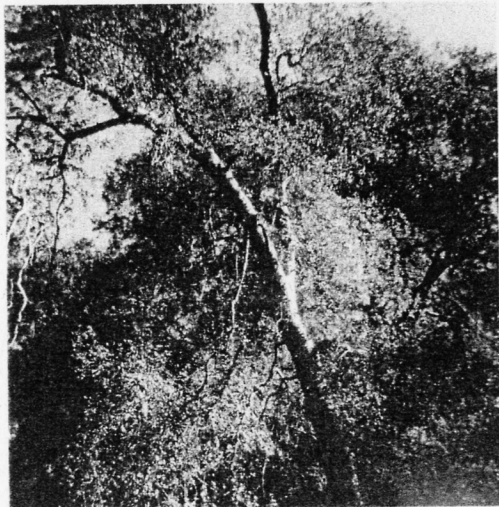
Photograph 36. View of coast live oak showing a few dead secondary branches; tree no. 499.

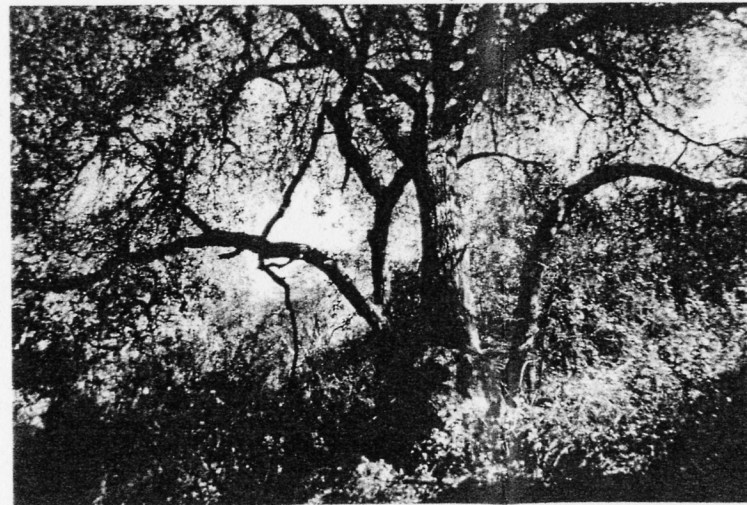
Photograph 37. View of large coast live oak on steep hillside showing exposed crown; tree no. 503.

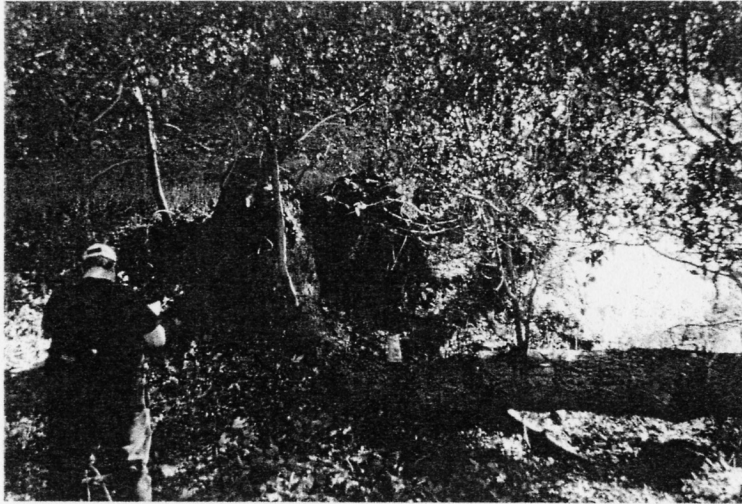
Photograph 38. Fallen coast live oak with exposed roots and sprouting trunk branches; tree no. 514.

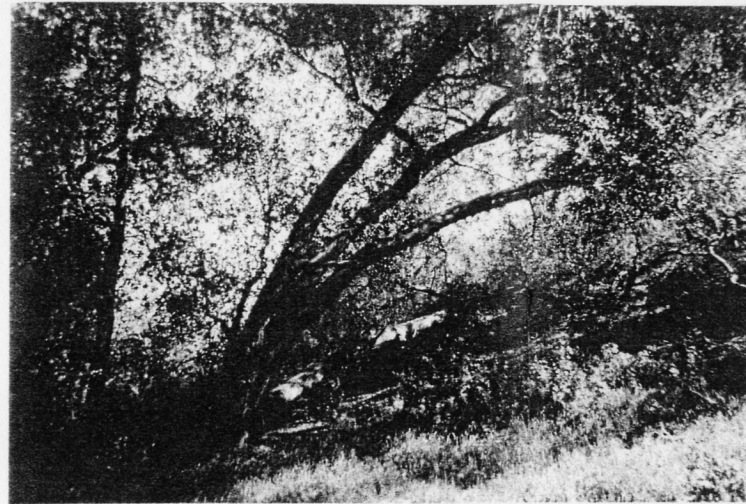
Photograph 39. View of multi-trunk coast live oak on steep hillside. Note severe lean; tree no. 516.

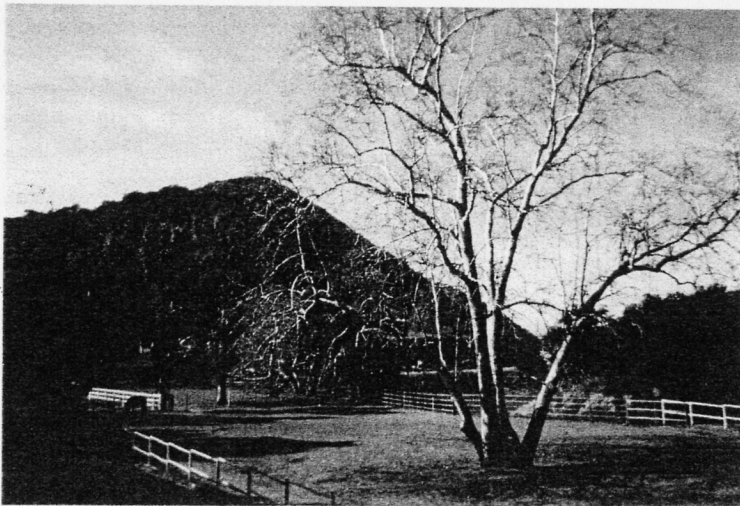
Photograph 40. View of large multi-trunk western sycamore. The central trunk has a 39-inch DBH; tree no. 517.

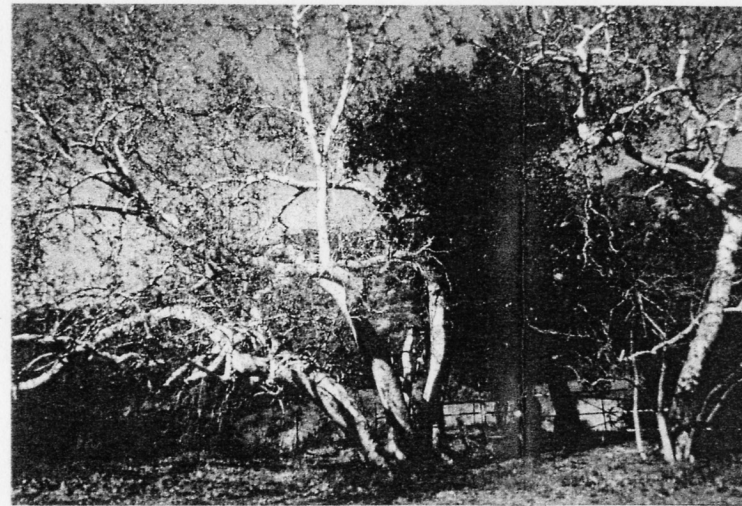
Photograph 41. View of western sycamores (tree no. 521 on the right and tree no. 522 on the left) and a coast live oak in the center (tree no. 521).
