THE J. BYER GROUP, INC.
A GEOTECHNICAL CONSULTING FIRM
1461 E. CHEVY CHASE DR. #200, GLENDALE, CA 91206
818.549.9959 TEL 818.543.3747 FAX
"Trust the Name You Know"

August 28, 2001
JB 18457-I

Addendum Geologic and Soils Engineering Exploration Report #3
Proposed Landslide Repair and Multi-Unit Condominium and Town Home Buildings
Tentative Tract 52928, Lot 1 (Condominiums)
17331-17333 Tramonto Drive
Pacific Palisades, California

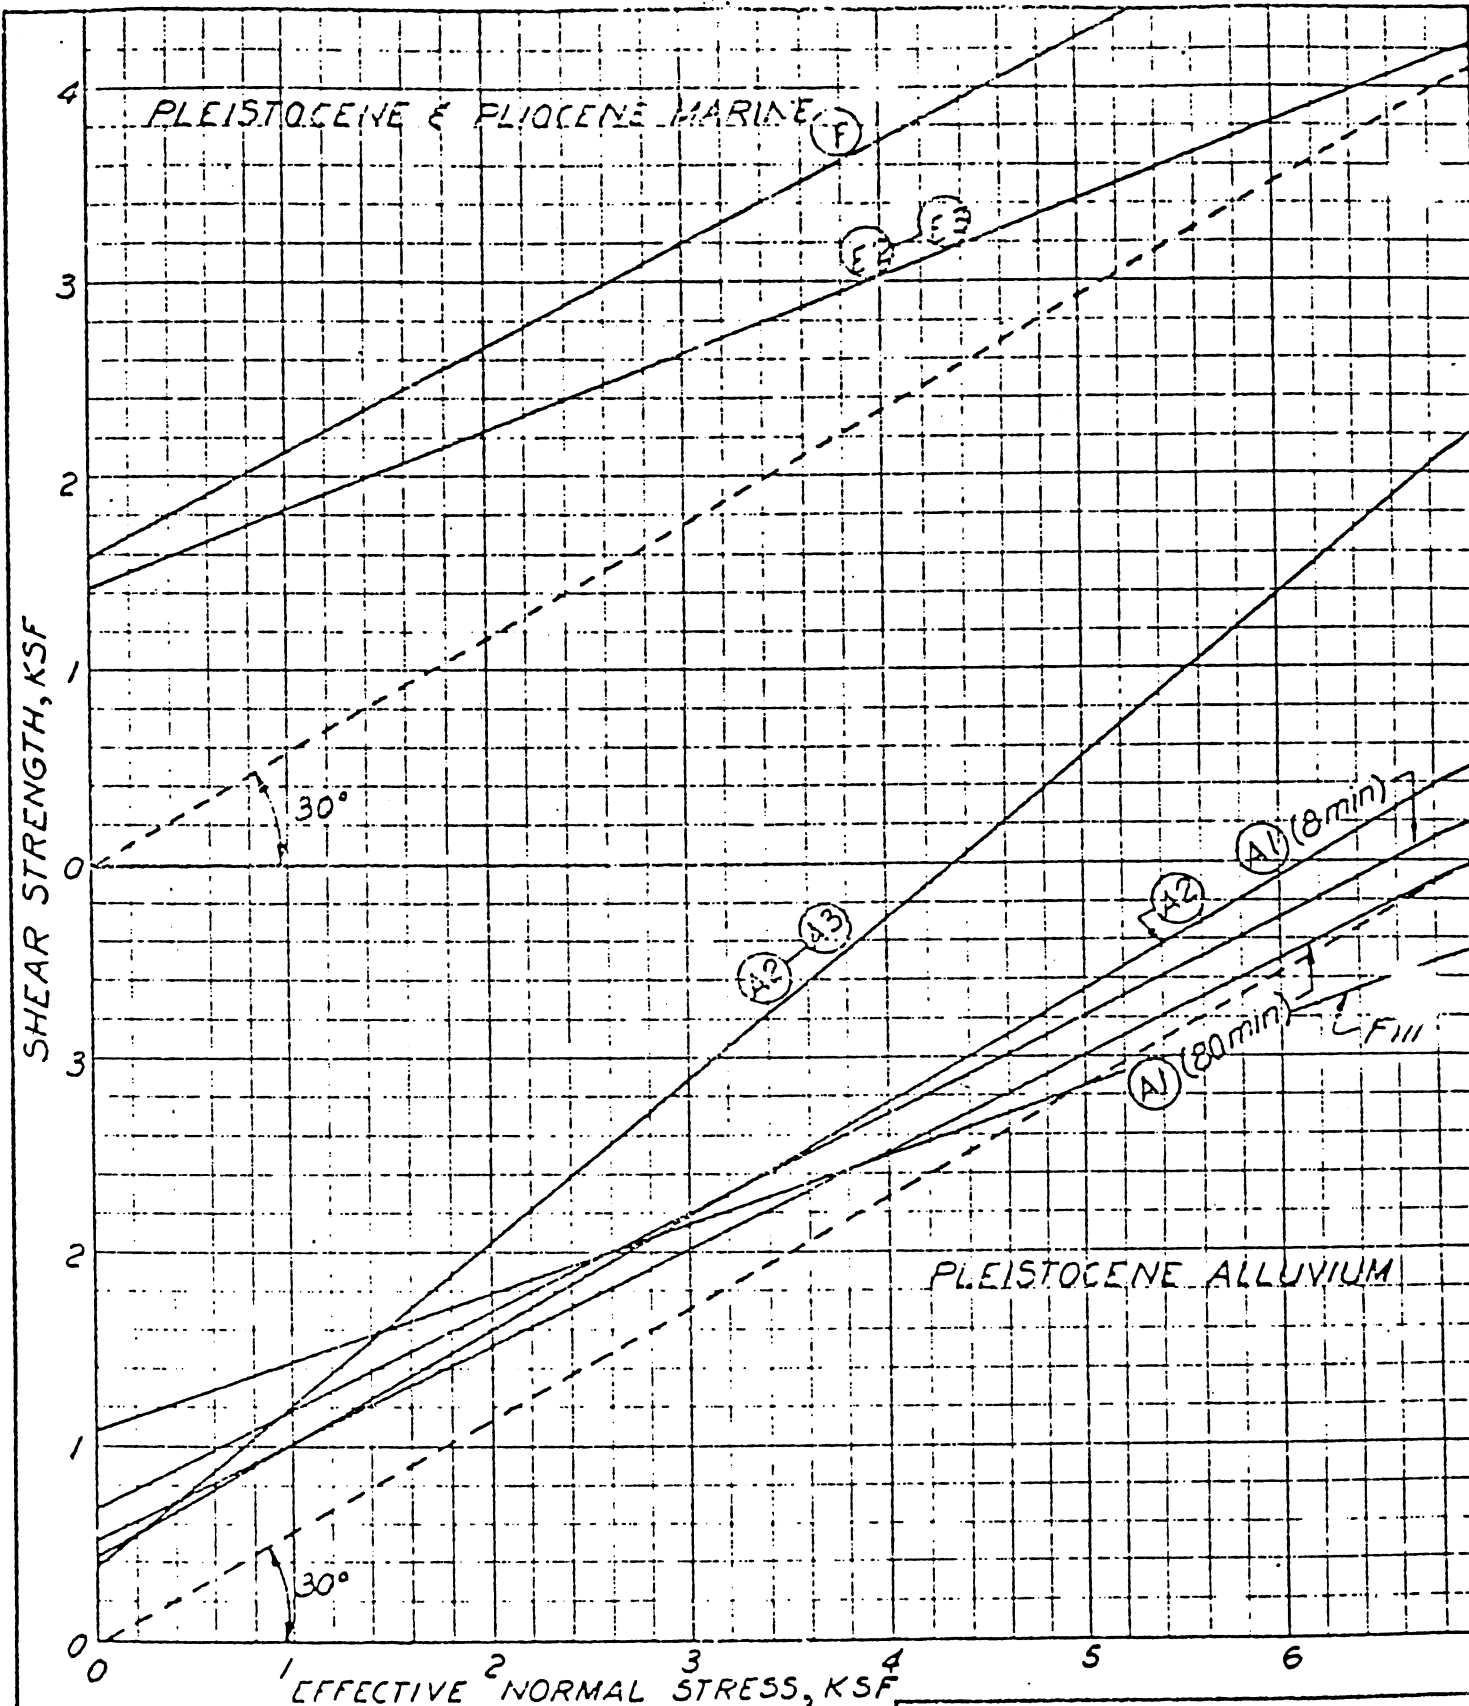
FILE NO. 1245A	PLATE NO. 10
-------------------	-----------------

Fill tested was obtained from boring 102A at Central Pacific Palisades, Slide Location 1.

A study of the Pacific Palisades by Moran, Proctor, Muesser & Rutledge, 1959 (*Final Report, Pacific Palisades Landslide Study*) contains shear test results of nearby terrace. Table 6 - Summary of Strength Test Results of Principal Subsoil Strata and Plate No. 10 - Strength Summary of Pleistocene-Pliocene Materials are enclosed.

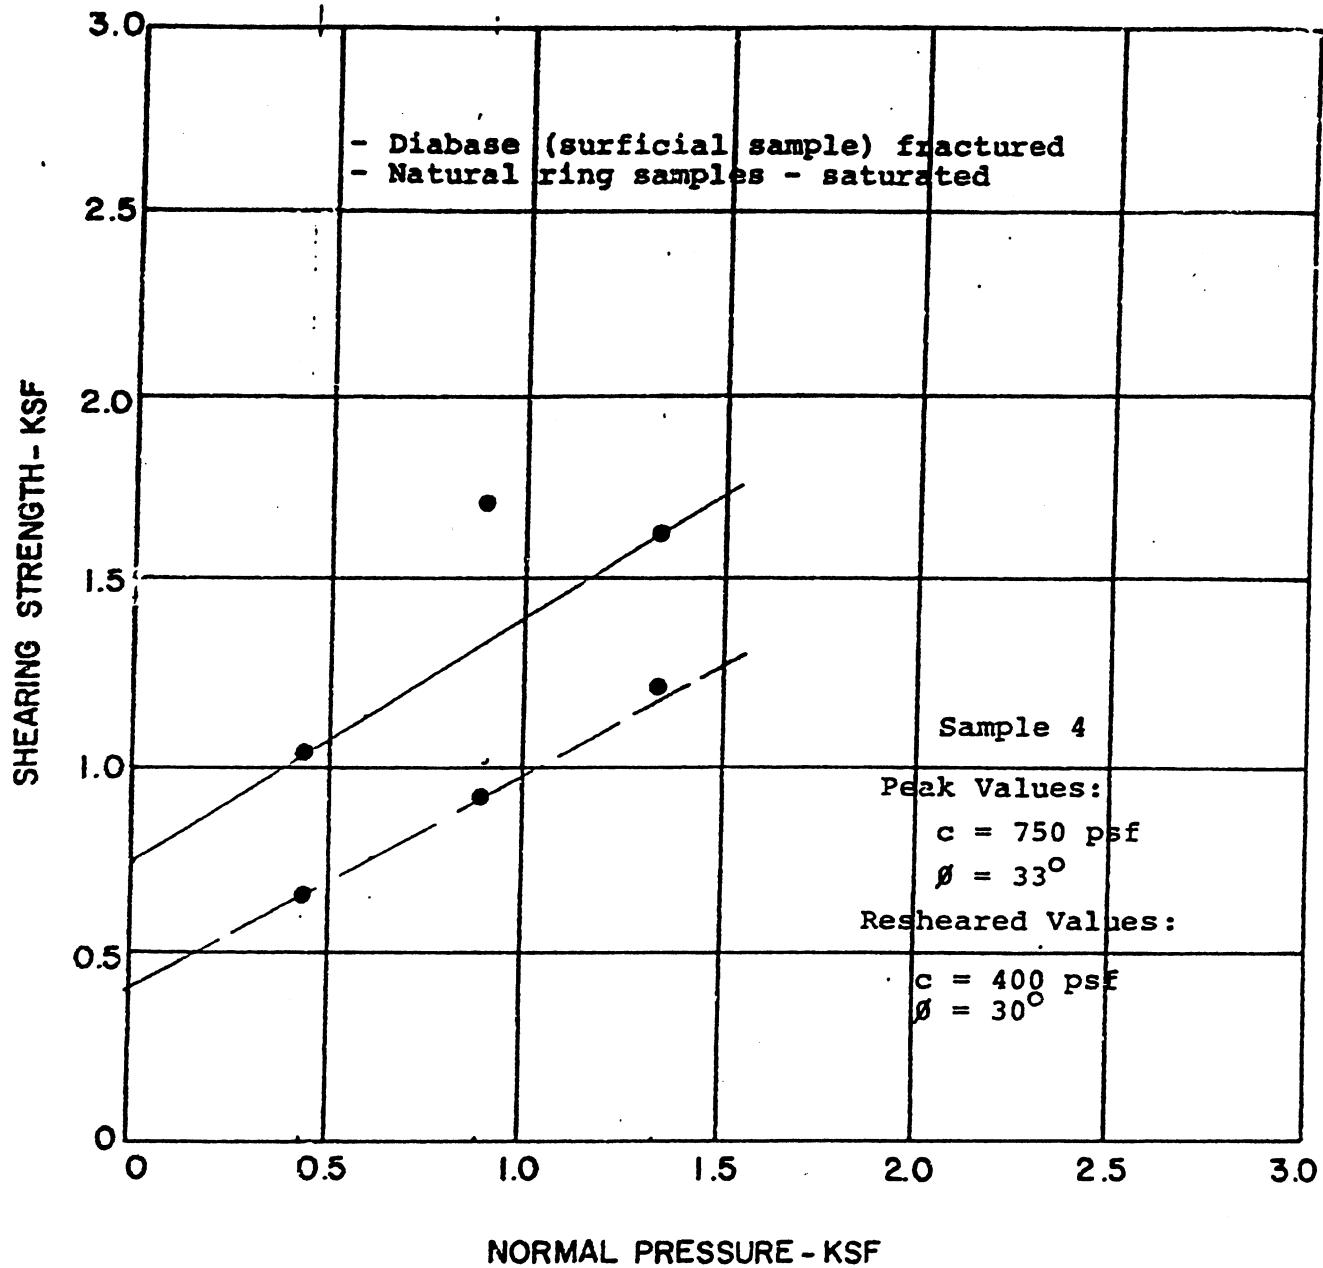
SHEAR TEST DIAGRAM

- TESTS AT FIELD MOISTURE CONTENT
- TESTS AT SATURATED MOISTURE CONTENT

Item - 6 *Provide a statement of responsibility indicating that shear strength obtained from Moran et al. report were reviewed and concurred with. Also provide shear strength diagram for the basalt and terrace stratum and conditions of the tests.*
